M2A1 Machine Gun, Caliber .50

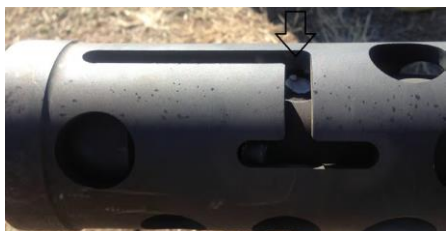
Picture 5

Failure to properly install the M2A1 barrel into the barrel extension will cause the weapon to malfunction and damage the barrel assembly by shearing the barrel alignment guide pin off of the barrel. Once the barrel alignment guide pin is sheared off, the barrel is non-repairable and the unit must then buy a replacement barrel for a cost of \$1,741 per barrel. The costs associated with replacing the damaged barrels so far have been approximately \$30,000 to date.

Picture 5: M2A1 barrel alignment guide pin is sheared off due to improper barrel installation.

When installing the barrel into the M2A1 receiver, barrel installation procedures must be followed in accordance with TM 9-1005-347-10 (WP 0023 00-3 and WP 0023 00-4). Failure to adhere to the steps in sequence will result in weapon malfunction, damage to the barrel assembly, and/or the M2A1 receiver.

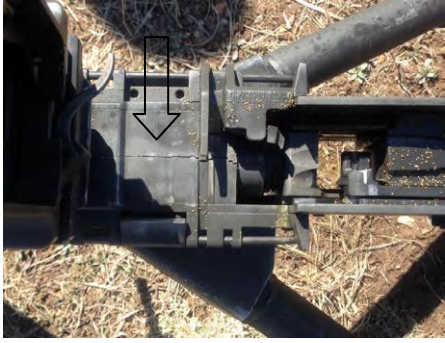
Picture 6

Picture 6: The cracked M2A1 receiver is the result of pressure from an unsupported ammunition cartridge due to improper barrel installation.
