DEPARTMENT OF DEFENSE VIRTUAL CORROSION CONFERENCE 2013

DiEGME Resistant Materials for Fuel Tank Protection

ABSTRACT

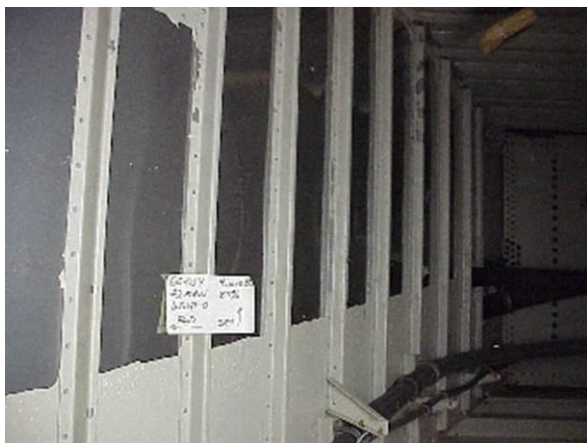
Figure 1: FTTP, B-52 aircraft, stopping at fuel line (Tinker-AFB)

The USAF first observed FTTP in the ullage of the B-52 aircraft in 1995, approximately 1 year after the conversion from JP-4 to JP-8 (Figure 1). The conversion to JP-8 is significant because DiEGME is less soluble in both JP-5 and JP-8 than in JP-4. This decrease in solubility has led to an increased concentration of DiEGME in the ullage and tank bottoms where water resides.

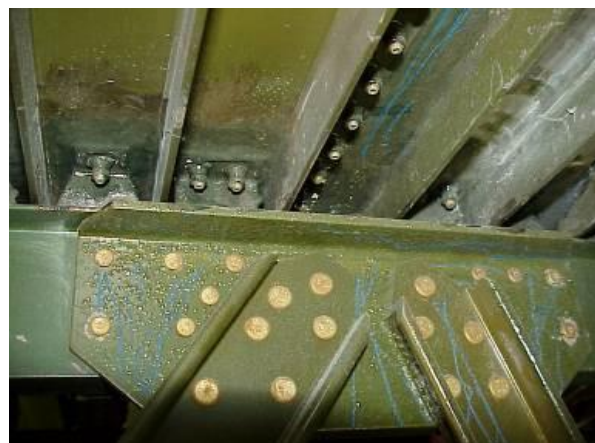
Figure 2: Fuel tank topcoat blistering in a P-3 aircraft (FRC-SE)

The Navy began seeing FTTP in the P-3 aircraft in the early 2000's (Figures 2, 3, 4). The P-3 FTTP is less severe than that of the B-52 because the B-52 is routinely operated with less than a full fuel load for takeoff/weight considerations. Therefore, the B-52 has an increased ullage area when the aircraft is not flying. Also, the topcoat used on the exterior of the B-52 aircraft is less UV reflective than the P-3 topcoat leading to the possibility of increased fuel tank temperatures. FTTP in integral fuel tanks inevitably will occur regardless of the aircraft, but the rate will depend upon fuel tank conditions (i.e., temperature, humidity, etc.).

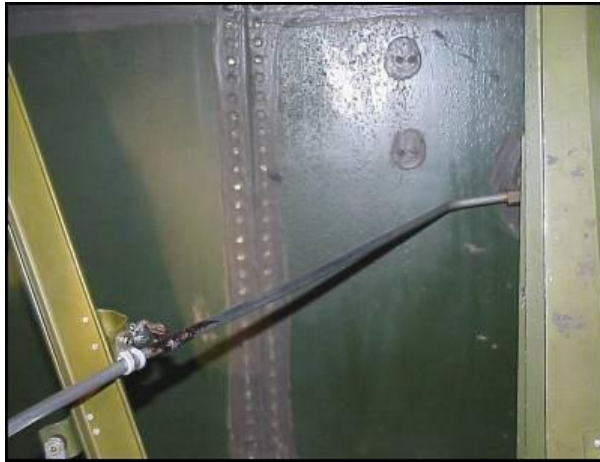
Figure 3: Fuel tank topcoat blistering in a P-3 aircraft (FRC-SE)

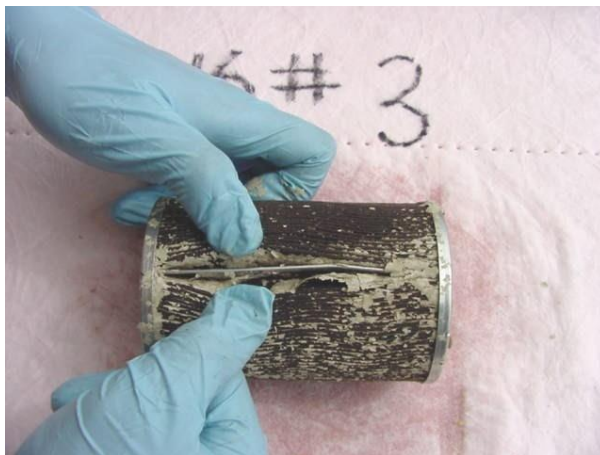
Figure 5: Paint chip contaminated fuel filter removed from a B-52 aircraft (Tinker-AFB)

The accumulation of paint chips in fuel filters (Figure 5) and pump screens (Figure 6) can lead to potential fuel starvation¹ to engines, a decrease in mission readiness, and increased man-hours required to keep fuel circuits clean.

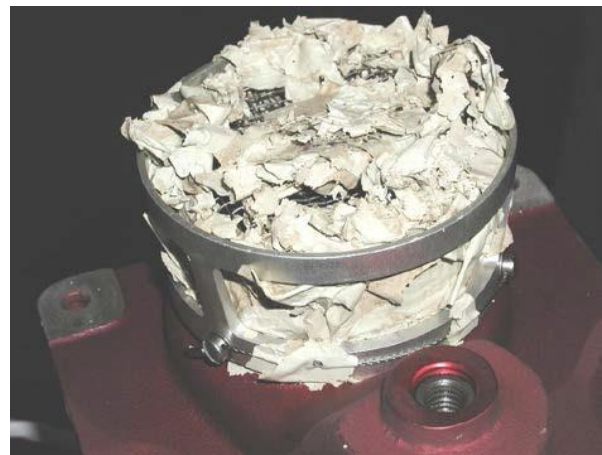
Figure 6: Main tank pump screen from a B-52 aircraft (Tinker-AFB)

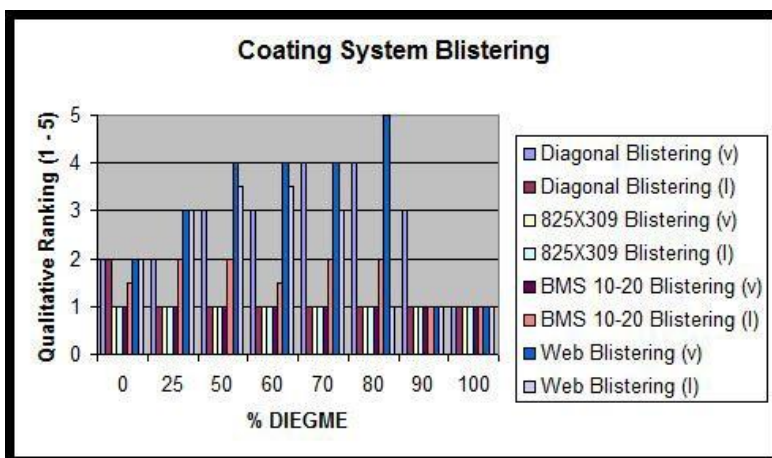
Figure 8: Blistering Data
(Qualitative Ranking 1 = no blisters, 5 = most blisters)

Initial NAVAIR testing was performed at FRC-SE, Jacksonville, FL and consisted of AA7075-T6 panels in enclosed Mason jars with a DiEGME/water mixture with concentrations ranging from 0 to 100% (0%, 25%, 50%, 60%, 70%, 80%, 90%, and 100%). Panels were exposed to both liquid (l) and vapor (v) conditions. The jars were placed into a cyclic environmental chamber and cycled between temperatures of 150°F for 20 hours and 10°F for 4 hours over a 30 day period. This testing confirmed that the presence of both water and DiEGME in a condensing environment is needed to replicate the conditions for fuel tank coating degradation. Coating degradation was assessed by blistering (Figure 8), adhesion (Table 2), and pencil hardness data (Table 3). This testing also showed that increasing water concentration increases conversion coating depletion, as observed by color change of the Alodine 1200S conversion coating (Figure 9). A depletion of conversion coating can contribute to corrosion of the fuel tank.

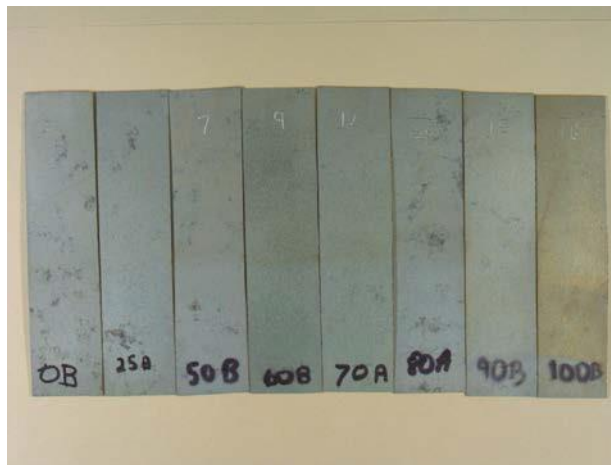
Figure 9: Panels showing depletion of chromate conversion coating with increasing water concentration left to right is decreasing water concentration.

The coating degradation/adhesion loss is the result of the swelling of the integral fuel tank coating and the ingress of water. The evidence of chromate conversion coating depletion³ may contribute to osmotic blistering due to the presence of the inorganic salts at the coating/substrate interface creating an osmotic gradient⁴. Inorganic salts in the form of chromic acid-chromic salts are present in conversion coatings utilized in integral fuel tanks. In addition, inorganic salts within the coating itself also can contribute to osmotic blistering. Most protective coatings will impede water intrusion to the coating-substrate interface, but the swelling of the coating by DiEGME uptake^{5,6} makes for ease of water ingress.

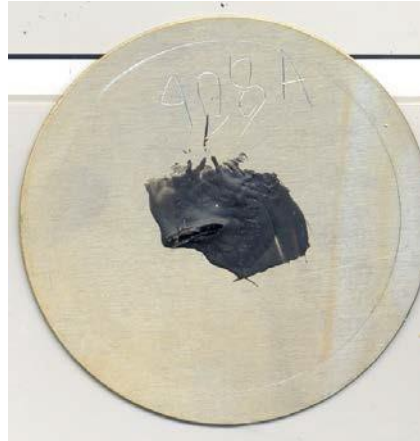
Figure 11: Conversion coating dry line

Testing performed at FRC-SE concluded that DiEGME concentrations between 70-90% provide the highest detrimental coating effects from blistering, color change, and conversion coating depletion collectively. Some coatings are more sensitive to proper conversion coating application than others as is seen by the adhesion loss (Figure 10) coinciding with the conversion coating "dry line" (Figure 11).

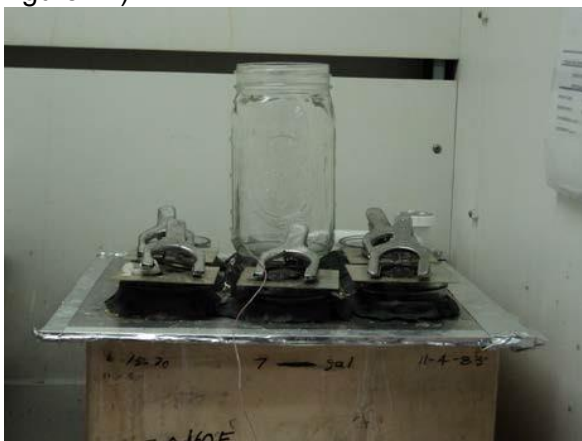
Figure 12: Test apparatus with the tops of the jars subjected to ambient conditions

The number of candidate coatings was increased during follow-on testing at NAS-PAX and an alternative condensation testing environment was further examined. Test panels were exposed to the vapor phase of the Mason jar test apparatus by vertical suspension and horizontally resting the panels across the jar opening. The jars were heated to 170°F with the tops of the jars being subjected to ambient laboratory conditions to induce condensation (Figure 12). An 80% DiEGME/20% water mixture was selected for use due to previous testing indicating that greatest coating degradation occurred between 70-90% DiEGME. Additionally, water is considerably more volatile than DiEGME and it was determined that a < 90% DiEGME concentration can easily be achieved when considering loss due to specimen “drag out” or evaporation. To maintain a DiEGME solution between 70-90% it was determined that the entire solution should be replaced after a 10% solution loss. Test panels were exposed for up to 35 days and evaluated periodically for blistering, adhesion, and pencil hardness.

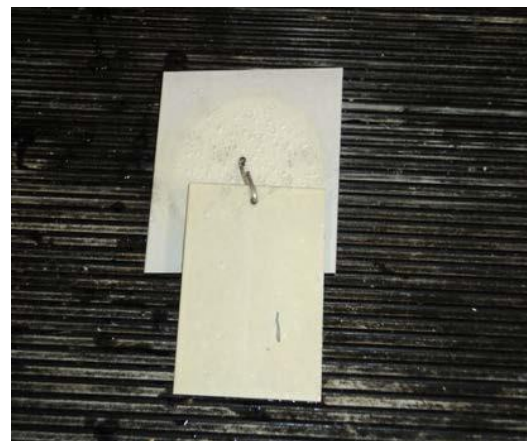
Figure 13: Vertical panel intact and the horizontal panel blistering

Concurrently, the Coatings Technology Integration Office (CTIO-WPAFB) collaborated with NAVAIR PAX and performed similar condensation testing in an effort to achieve an agreed upon test protocol for addition to SAE AMS-27725 as well as a new coating type for DiEGME resistance. These collaborative efforts confirmed evidence of different modes of failure as is evident by the blistering on the horizontal panel (Figure 13) and the pencil hardness data (Figure 14).

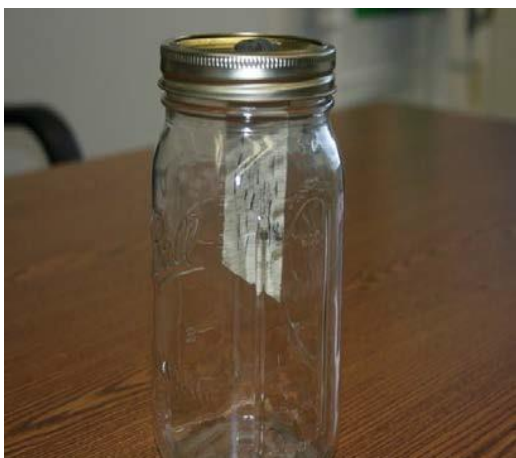
Figure 15: Test specimen jar and panels

Subsequent testing was performed with inserts of AA7075-T6 that were manufactured to fit inside the screw tops of the Mason jars to minimize evaporation (Figure 15). The panels were examined for visual defects and pencil hardness at ~30 day intervals to reduce solution drag out. In addition, the heating (165°F) of the Mason jars was confined to only that of the solution filled volume (~350 ml). This was done to further increase the condensation on the vertical hanging and horizontal panels (Figure 16). The temperature and testing protocol change was a collaborative decision made by CTIO-WPAFB and NAS-PAX for consistency of testing.

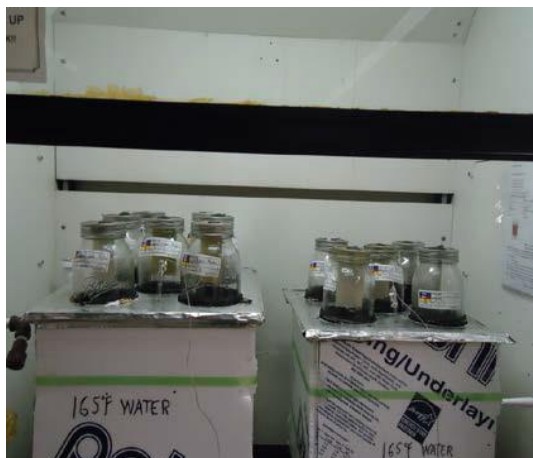
Figure 16: Test apparatus, only solution heated.

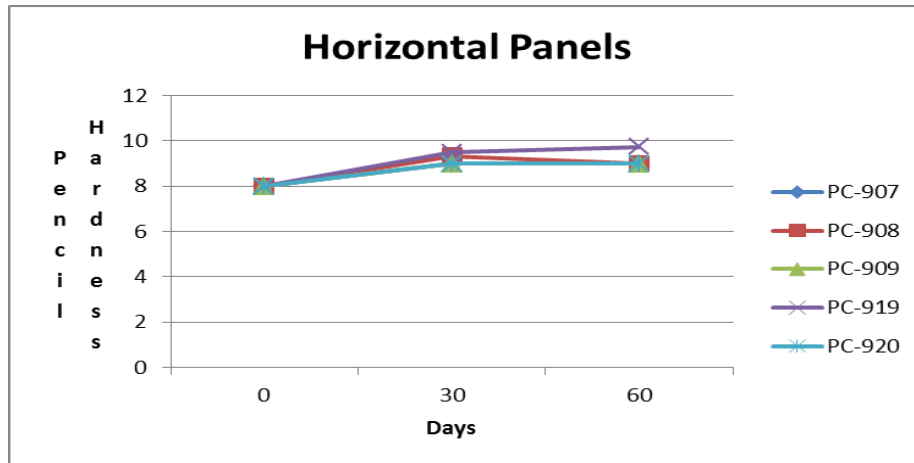
Figure 19: Pencil Hardness Results for Down-Select Horizontal Panels

Based on previous test results, a down-selection was performed on the coatings. Coatings that exhibited a decrease in pencil hardness of greater than two units or the adhesion loss/blistering of the coating were removed from further testing. Further testing was performed on down-selected coatings to verify reproducibility. The vertical and horizontal panels exhibited equivalent behavior in regards to pencil hardness (Figures 19, 20). Representative 60 day exposure panels (Appendix A) show wet tape adhesion results. Two PPG products and one Deft product exhibited blistering and adhesion failure attributed to a conversion coating deficiency. Averaged adhesion results disregarding conversion coating deficiency show that there are failures on both the horizontal and vertical panels (Table 4). One of the Deft coatings leached into the DiEGME/water solution as was seen by the “milky” solution color (Appendix A).

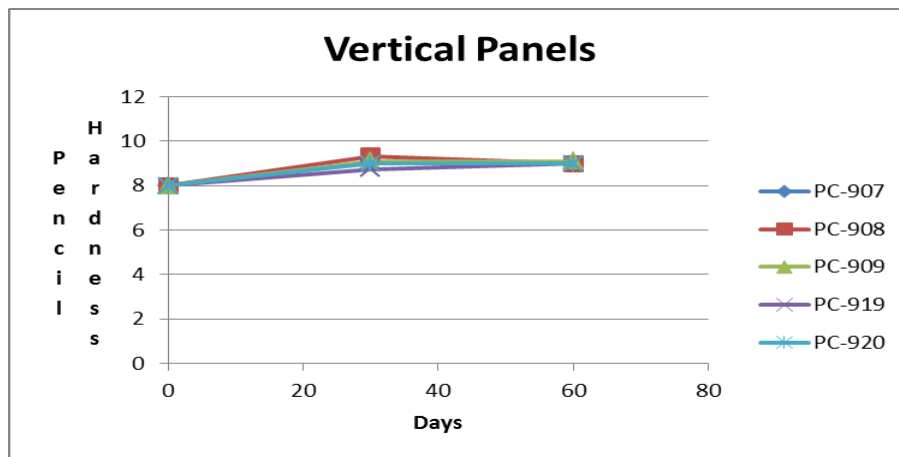
Figure 20: Pencil Hardness Results for Down-Select Vertical Panels

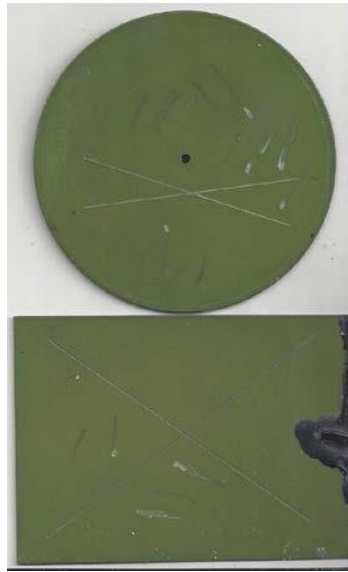
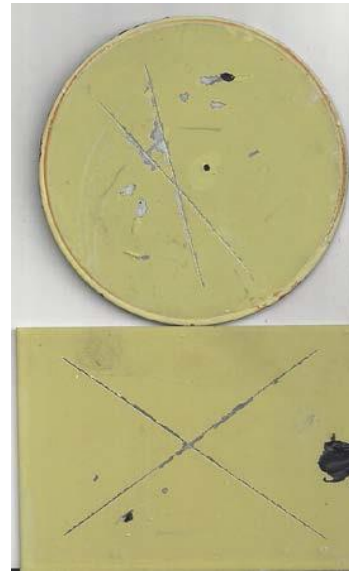
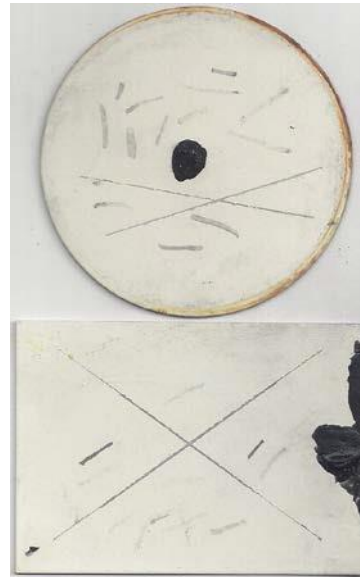
PC-908
60 days@170F, 80/20

60 days@170F, 80/20

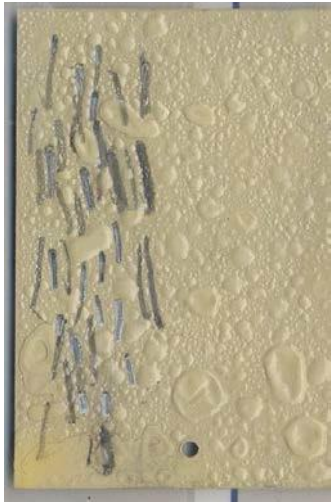
PC-808, 47 days@170F, 80/20

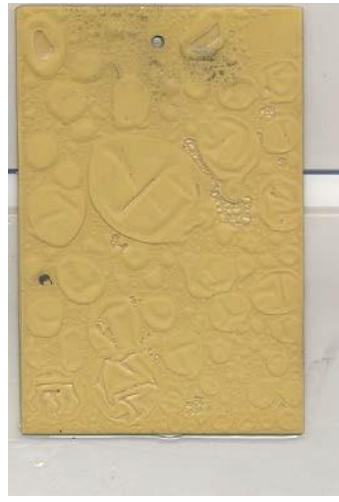
PC-796, 26 days @170F, 80/20

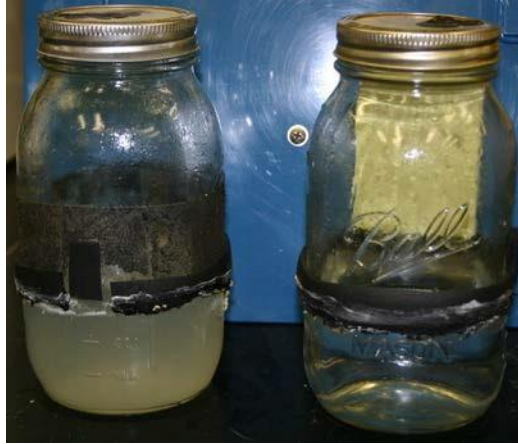
Example of the leaching of a coating
