HOT CORROSION OF GAS TURBINE MATERIALS IN THE MARINE ENVIRONMENT

David A. Shifler
Carderock Division, Code 613
Naval Surface Warfare Center
9500 MacArthur Boulevard
West Bethesda, MD 20817-5700

Type I and II hot corrosion attack has been observed on certain marine gas turbine engines in the area of the first stage turbine hardware. In order to improve the service life of these engines, laboratory testing of the current, baseline coating and several candidate replacement coatings was initiated using a low-velocity, atmospheric-pressure burner-rig (LVBR). This paper examines the LVBR results of these high temperature coatings on Alloy M247 to determine the hot corrosion resistance relative to the baseline coating with the goal of replacing the current baseline coating better performing coating system.

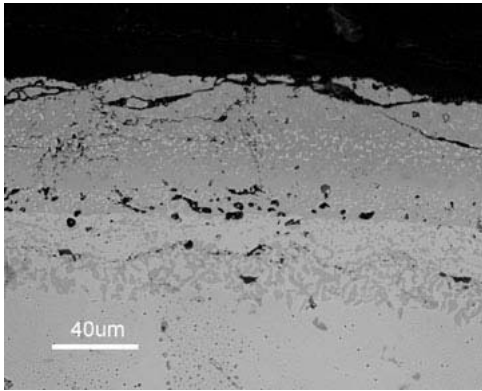
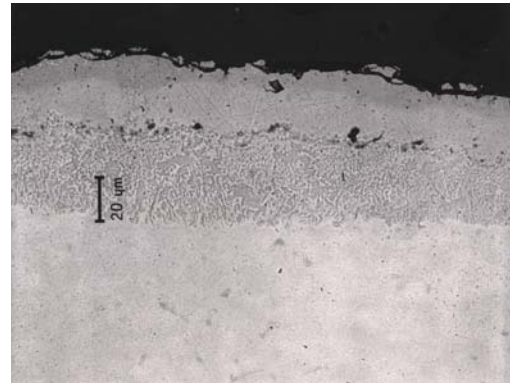
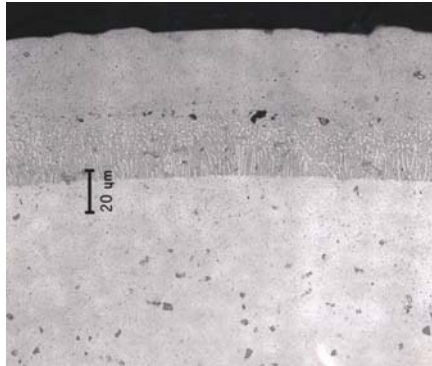
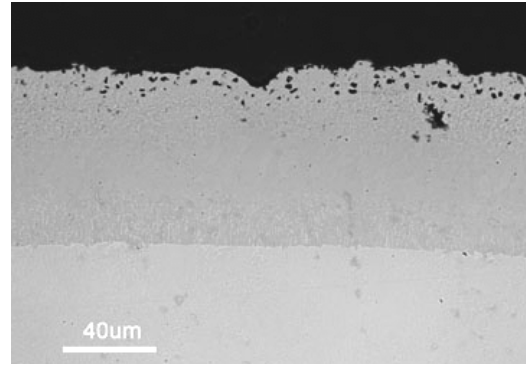
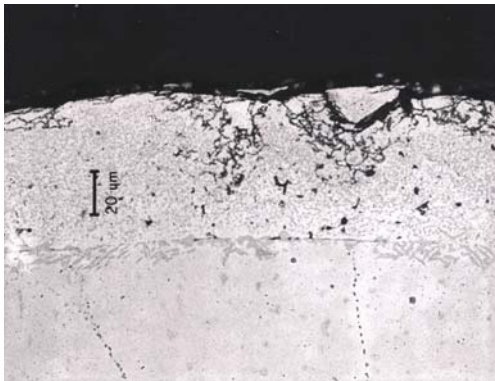
Figure 1 – Untested coated pin specimens, 500X. Shown are (a) Layered MCrAlY, (b) Coating 24, (c) Coating 150, (d) Coating 2E, and (e) baseline Coating 71.

Figure 1 shows the general features of the different coatings prior to testing. The baseline blade coating (Coating 71) was applied by argon-shielded plasma spray. A two-step process involving argon-shielded plasma spray followed by an AEP (electrophoretic diffused platinum aluminide) topcoat formed the layered CoCrAlY. Coatings 150 and E2 were both applied by electroplating. However, Coating 150 is subsequently aluminized using chemical vapor deposition and various heat treatments, while Coating E2 is aluminized by pack cementation. Coating 24 is processed by a proprietary electrophoretic process and subsequent aluminizing process. Table 2 summarizes the coated pin LVBR test matrix.

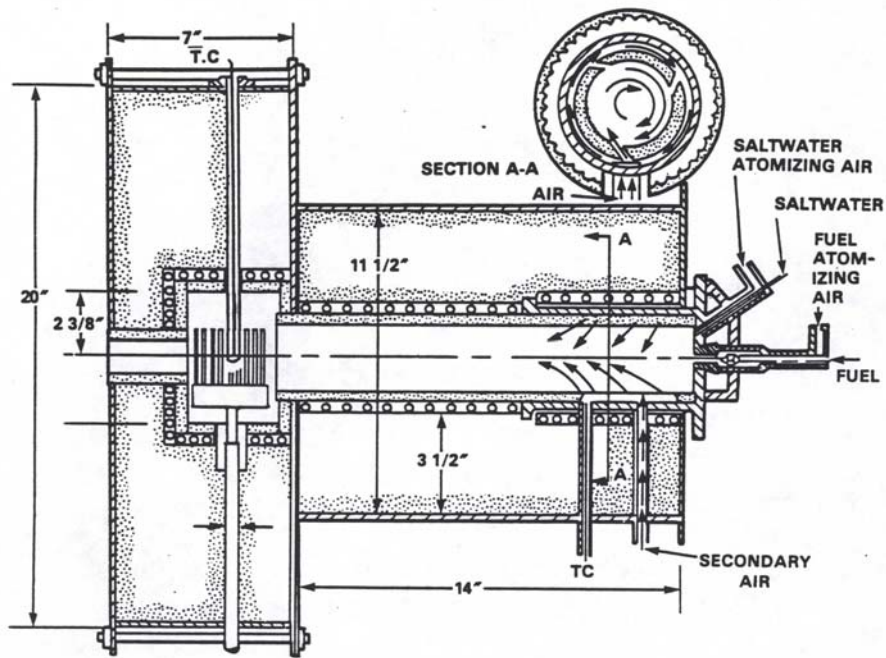
Figure 2 - Cross-sectional view of low-velocity, atmospheric pressure burner rig.

A low-velocity, atmospheric pressure burner-rig (LVBR) was utilized to evaluate the hot corrosion resistance of candidate hot-section vane coating systems using sulfur-doped NATO F-76 (described earlier). Details of burner rig operation were described previously [5,6]. A schematic cross-sectional illustration of the burner rig is shown in Figure 2. The gases added to the fuel stream are thoroughly mixed by the swirling action of air entering through the tangential slots in the combustion tube. Downstream, the test pins are exposed to the products of combustion in a carousel rotating at 29 rpm to assure uniform temperature exposure of all test specimens. The air/fuel ratio during all LVBR tests was 30:1.

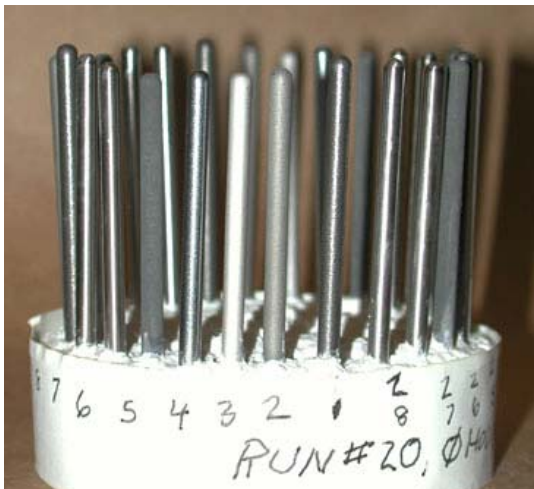
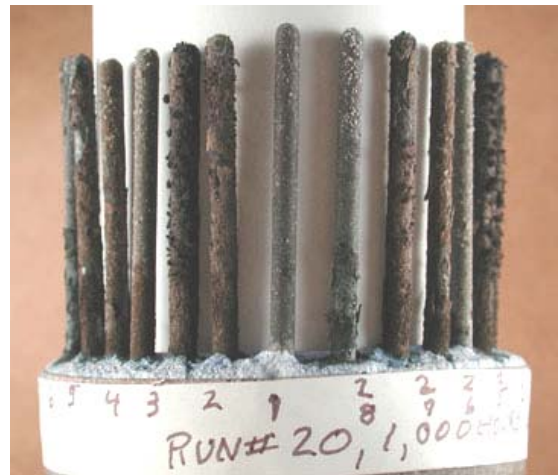
Figure 3 – (a) shows the appearance of the LVBR test pins in carousel prior to LVBR exposure while (b) illustrates the pin conditions after 1000 hours LVBR Exposure at 1300 °F (704 °C) for pins 26-6. Coatings of pins 1 (the baseline) and 4 (Coating 150) are virtually unaffected while pins 2,3 5, and 6 show significant degradation.

Figure 3a shows the condition of coated pins in the LVBR carousel prior to exposure at 1300 °F (704 °C). Localized degradation of several coated pins observed as dark spots on the coatings was discovered after only 99 hours exposure. Surface deposits, though noticeable from the initial exposure times, were observed to substantially accumulate with continued exposure time. Sea salt deposition continued to become heavier, particularly along the top and middle elevations with increased LVBR exposure.

The LVBR test was completed after 1000 hours of exposure at 1300 °F (704 °C). Many of the pins showed significant level of coating distress with the exception of the pins coated with Coating 24, Coating 150, and the baseline Coating 71. Figure 3b shows the condition of the pins after 1000 hours of LTHC exposure.

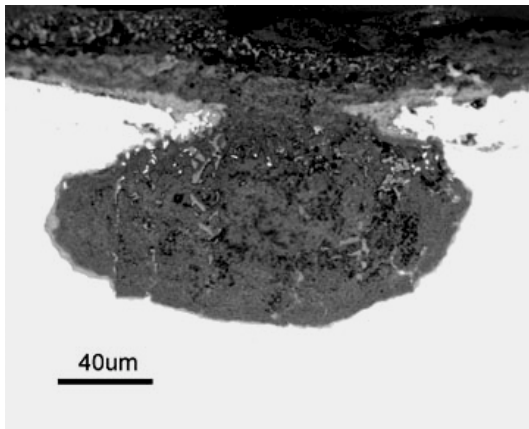
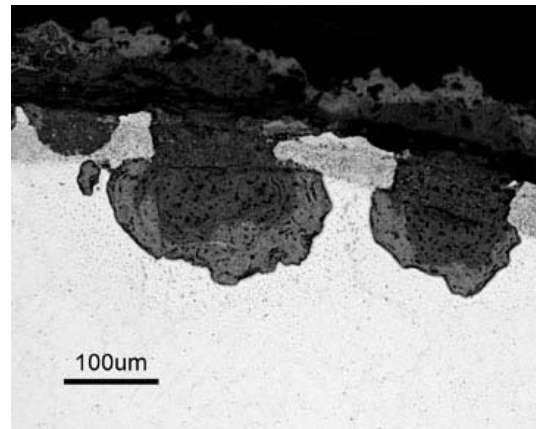
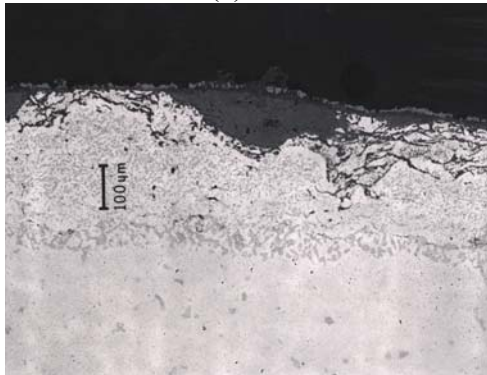
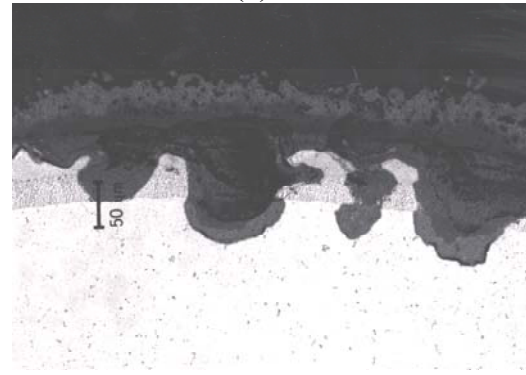
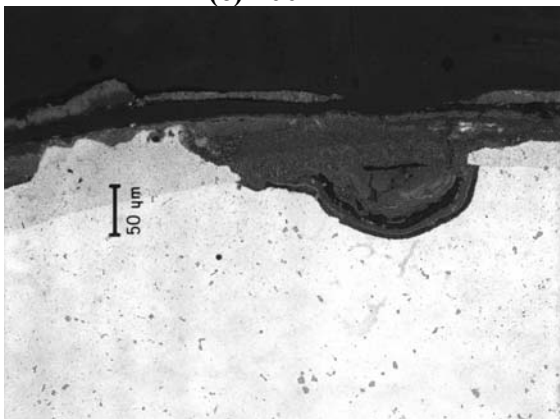
Figure 4 – Coating after 1000-hr LVBR test at 1300 °F (704 °C). In (a) Layered MCrAlY Type II hot corrosion found along coating surface. In (b) localized, pitting-type penetration of Coating 24 is observed. Figure (c) shows the baseline coating loss has occurred near some oxide stringers, while Figure (d) displays the Type II hot corrosion of Coating 150. Figure (e) displays the complete coating penetration for a test pin with Coating E2.

Though most of the coatings experienced little to moderate corrosion, a few sites were subjected to severe corrosion. The layered MCoCrAlY experienced considerable hot corrosion degradation of its coating. Figure 4a shows one site where the coating has been completely penetrated by the activity of Type II hot corrosion. Similar penetration of the Coating 24 (Figure 4b) and Coating 150 (Figure 4d) were also observed. Hot corrosion of the baseline coating (Coating 71) shown in Figure 4c tended to proceed near oxide stringers that were artifacts of the plasma spray process. Figure 4e displays one of the numerous sites of coating penetration on a LVBR test with Coating E2.

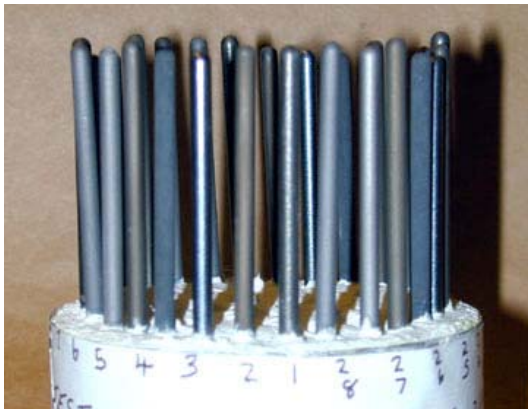
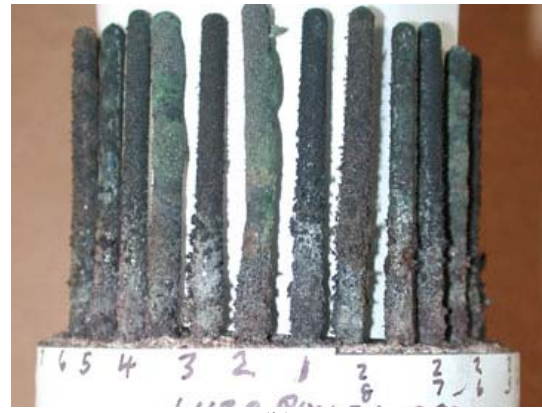
Figure 5 – (a) shows the LVBR pins prior to exposure at 1650 °F (899 °C). Salt deposition accumulated on the pin surfaces during the LVBR exposure. (b) shows the degree of accumulation after 999 hours. The bottom elevation has particularly heavy deposition.

Figure 5a shows the test pins prior to exposure. Surface deposits began to form on the LVBR test pins almost immediately upon exposure at 1650 °F (899 °C). The deposition was particularly heavy about 1.5-inch (3.8-cm) from the top (approximately the bottom elevation for subsequent pin measurements). Figure 5b shows the degree of accumulation that occurred after 999 hours of exposure.

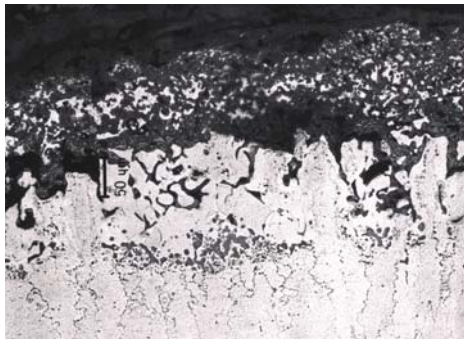
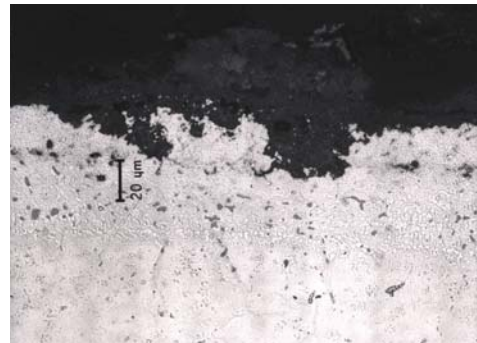
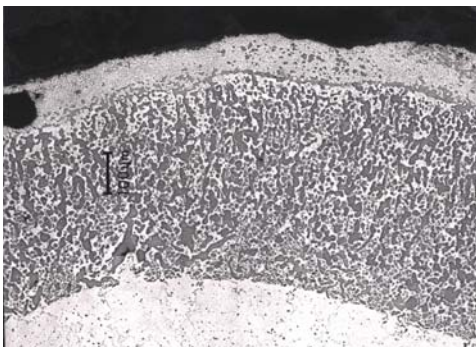
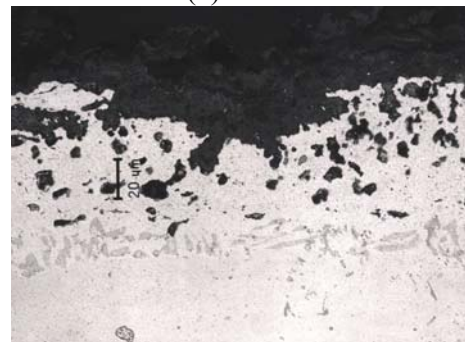
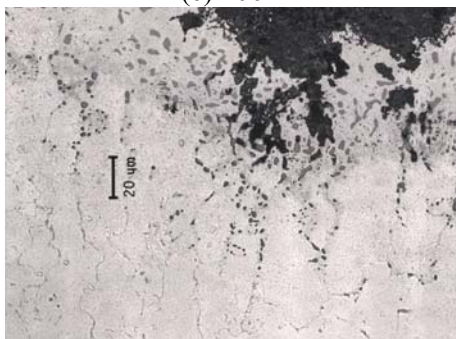
Figure 6 Photomicrographs of coated pin samples after 1000-hr LVBR test at 1650 °F (899 °C). (a) baseline CoCrAlY, (b) Coating 150, (c) Coating E2, (d) Layered CoCrAlY, and (e) Coating 24.

Figure 6 shows some conditions typical of the substrate coating systems tested for resistance to Type I hot corrosion. The baseline, Coating 71 displayed broad frontal attack in the coating as is typical of Type I hot corrosion (Figure 6a). Coating 150 experience some pitting type-attack, but the general advance of degradation was by broad phasal attack as shown in Figure 6b. Coating E2 suffered from extensive loss of coating and subsequent sulfidation corrosion of the remaining coating and Alloy M247 substrate (Figure 6c). Critical coating constituents were subjected to interdiffusion with the alloy substrate which caused changes in coating composition and subsequent attack of the altered coating. Figure 6d shows Type I hot corrosion attack of the altered coating. Coating 24, shown in Figure 6e displayed sulfidation and penetration of the protective coating into the alloy substrate and some incipient intergranular corrosion of the alloy.

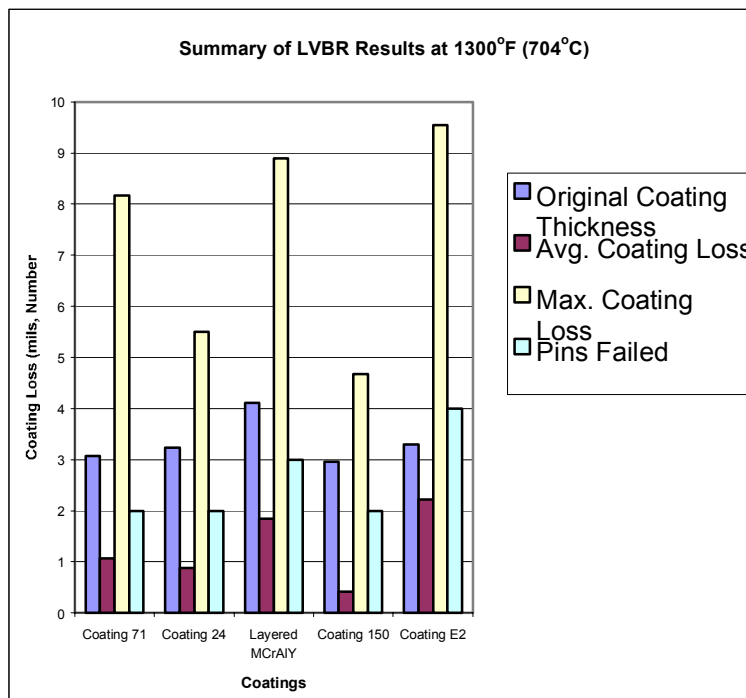
Figure 7 – Summary of LVBR test results on coatings performance (starting original thickness, average coating loss on a radius, and maximum penetration) in the low temperature hot corrosion regime (LTHC) at 1300 °F (704 °C).

The LVBR test results from the 1000-hr exposure at 1300 $^{\circ}\text{F}$ (704 $^{\circ}\text{C}$) are summarized in Figure 7. Absolute coating loss values provide a better comparison to the overall performance than the percentage loss. The LTHC ranking was based on resistance to Type II hot corrosion using both

average coating loss for a coating system set and the average maximum coating penetration for each set listed in Table 4 (in order of decreasing resistance to Type II hot corrosion) was: Coating 150, Coating 24, baseline Coating 71, Layered MCrAlY, and Coating E2.

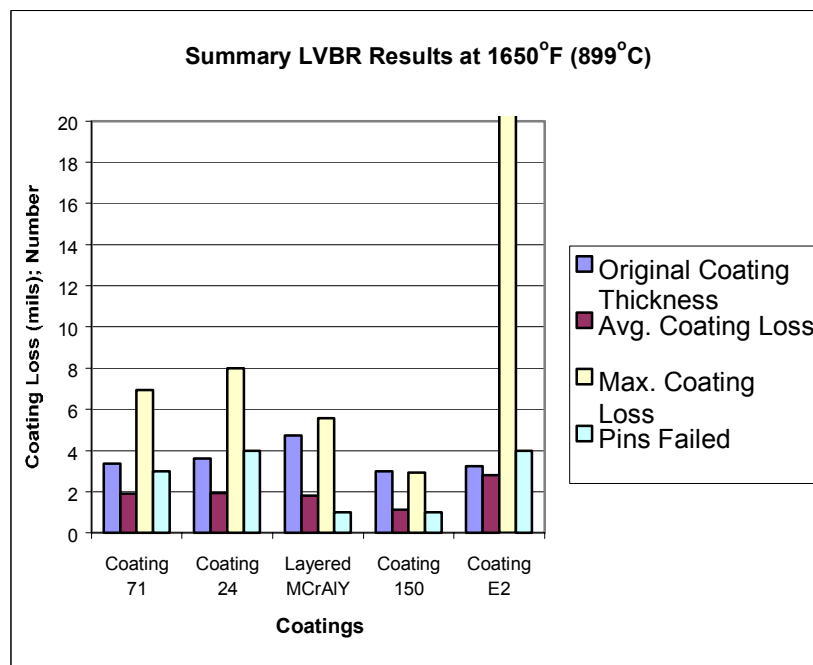
Figure 8 – Summary of LVBR coatings performance test results (original thickness, average coating loss on a radius, and maximum penetration) in the high temperature hot corrosion regime (HTHC) at 1650 °F (899 °C).

In the LVBR high temperature hot corrosion environment (HTHC) at 1650 °F (899 °C), Coating 150 had the least average coating loss among the coatings reported here. The LVBR test results from the 1000-hr exposure at 1650 °F (899 °C) are summarized in Figure 8. The HTHC ranking of resistance to Type I hot corrosion on the basis of measurements for both average coating loss for each coating set and the average maximum coating penetration for each set listed earlier in Table 5 (in order of decreasing resistance to Type II hot corrosion) was: Coating 150, Layered MCrAlY, baseline Coating 71, Coating 24, and Coating E2.
