## IMPLEMENTATION OF COMPOSITE SOLUTIONS IN SHIPBOARD TOPSIDE ELECTRICAL SYSTEMS

### BACKGROUND

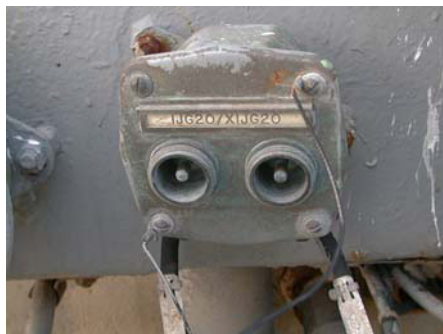
Figure 1 - Corroding Electrical Enclosure

In response the NAVSEA Corrosion Control Division initiated shipchecks starting in 2001 on the USS THEODORE ROOSEVELT (CVN-71), USS BARRY (DDG-52), USS COMSTOCK (LSD-45), and USS VELLA GULF (CG-72). These inspections showed that the metallic boxes corrode resulting in leakage and loss of electrical function, that the brass boxes are frequently repainted, and that the brass boxes corrode the ship structure. Figure 1 shows a picture of a corroding box with missing covers for the electrical connections that allows for moisture intrusion and loss of electrical function.

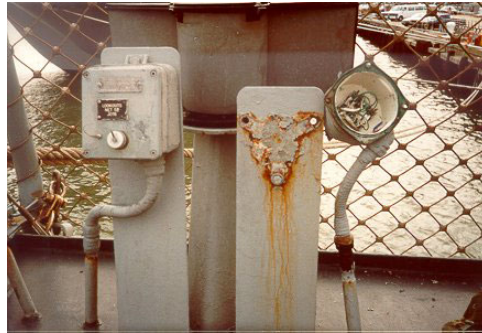
Figure 2 shows typical galvanic corrosion of the ship-structure to which a brass box was attached.

**Figure 2 - Ship-Structure Corrosion Resulting from Brass Enclosure**

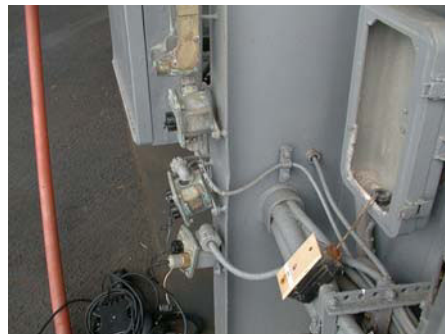
**Figure 3 - "Jury-Rig" Solution to Corroded Electrical Box**

The analyses further showed that boxes corrode and require repainting and repair every three years. Half the boxes are replaced every six years. Ship's force must repair the corrosion damage to these boxes because they are integral to the ship's operating or force-protection systems. Box failures can require ship's force to "jury rig" temporary extension cords and relays to accomplish critical functions like communicating operating commands to force-protection stations (e.g., 50-cal. machine gun mount crews communicate with the bridge by connecting sound-powered telephones to electrical boxes mounted on the ship's structure) or ensuring anti-swimmer security lights are functional. Figure 3 shows such a temporary "jury-rig" installation. In some applications, a shock-hazard associated with deteriorated electrical boxes forced ships force to engage switches with a wooden broom handle.

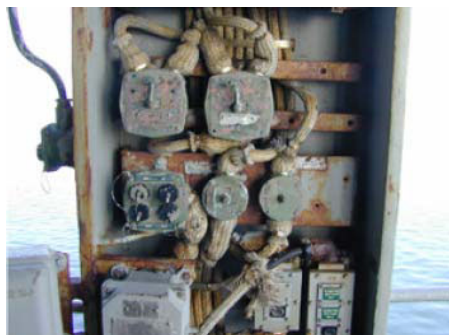
**Figure 6 - Corrosion-Prone Stern Gate Controller Area**

Field demonstrations were conducted on ships with corrosion prone enclosure installations. Navy amphibious ships operate in the littoral environment incident to USMC operations and experience attendant high levels of corrosion. The Navy LSD-41 and LSD-49 class ships were accordingly selected. The stern-gate controller area on these ships is exposed to considerable sea-spray, a very harsh environment (Figure 6).

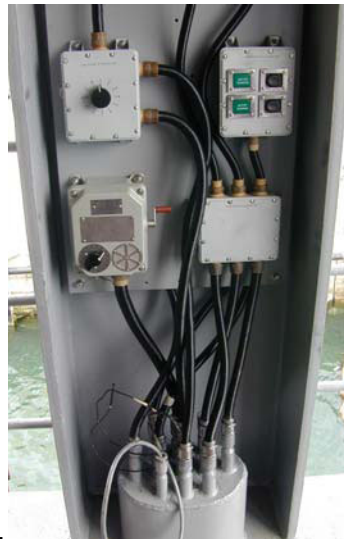
Figure 7 depicts a new installation of the composite boxes in the stern gate controller area.

**Figure 7 – New Composite Electrical Enclosure Installation for Stern Gate Controller**

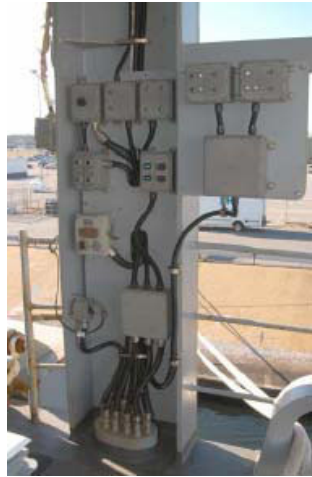
Figure 9 shows excellent performance of the same style enclosures on the USS GUNSTON HALL after 6 months exposure.

**Figure 9 - Composite Enclosures on USS GUNSTON HALL ( 6-Months)**

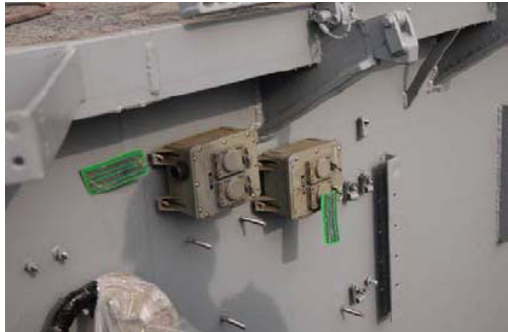
**USS GEORGE WASHINGTON (CVN-73).** Figure 10 shows the condition of the composite electrical enclosures on USS GEORGE WASHINGTON (CVN-73) after three (3) years of service. The figure shows the ship during a maintenance availability so the electrical conduit has been removed from the boxes. Despite its location on the weather deck area, no corrosion or deterioration was observed on the box or the hull structure.

**Figure 10 - Composite Enclosures on USS GEORGE WASHINGTON (Three Years Service)**

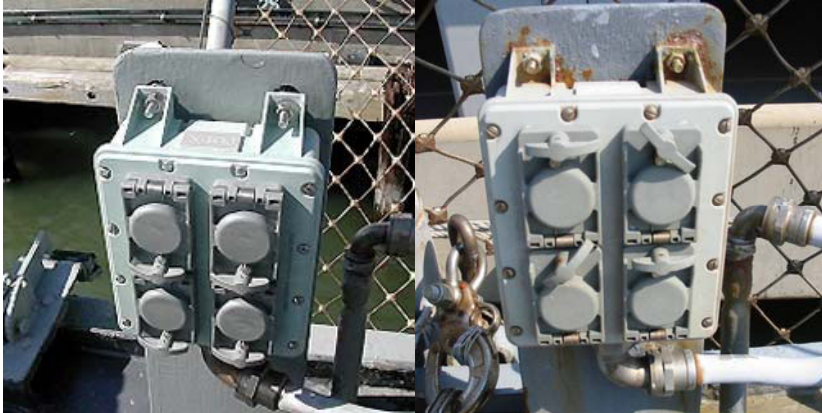
**USS BARRY (DDG-52).** Boxes have been installed on USS BARRY for about 5 years. Figure 11 shows a composite picture of these boxes at the time of installation (photograph on the left) vs. the boxes after five years of service (right photograph). The box itself remains in virtually the same condition as upon installation. The only sign of corrosion is weeping and staining emanating from the mounting holes where the boxes is attached to the ship structure.

**Figure 11 – USS BARRY Sound-Power Phone Box, Install (Left) and Five Years (Right)**

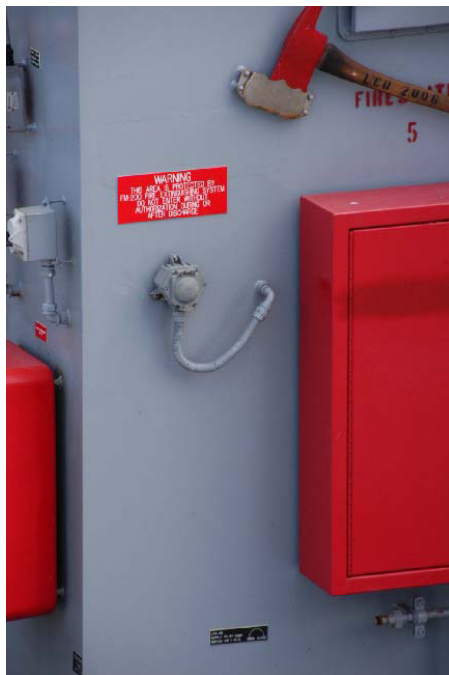
**US ARMY LCU-2006.** An opportunity existed to make an inspection of the USAV Bristoe Station, LCU 2006 after nominally 1 ½ years of service. All of the composite electrical enclosures appeared intact and free of corrosion. The ship has not reported any problems or maintenance needs associated with any of the installed components. Figure 12 shows a typical electrical box after 1 ½ years service.

**Figure 12 - Electrical Enclosure after 1 1/2 Years (LCU 2006)**
