DoD CORROSION CONFERENCE 2011

Prevention of Corrosion Related Failure of Aircraft Aluminum Using an Engineered Residual Stress Field

Jeremy Scheel,
Paul Prev y and Douglas Hornbach
Lambda Technologies
5521 Fair Lane
Cincinnati, Ohio 45227-3401
jscheel@lambdatechs.com

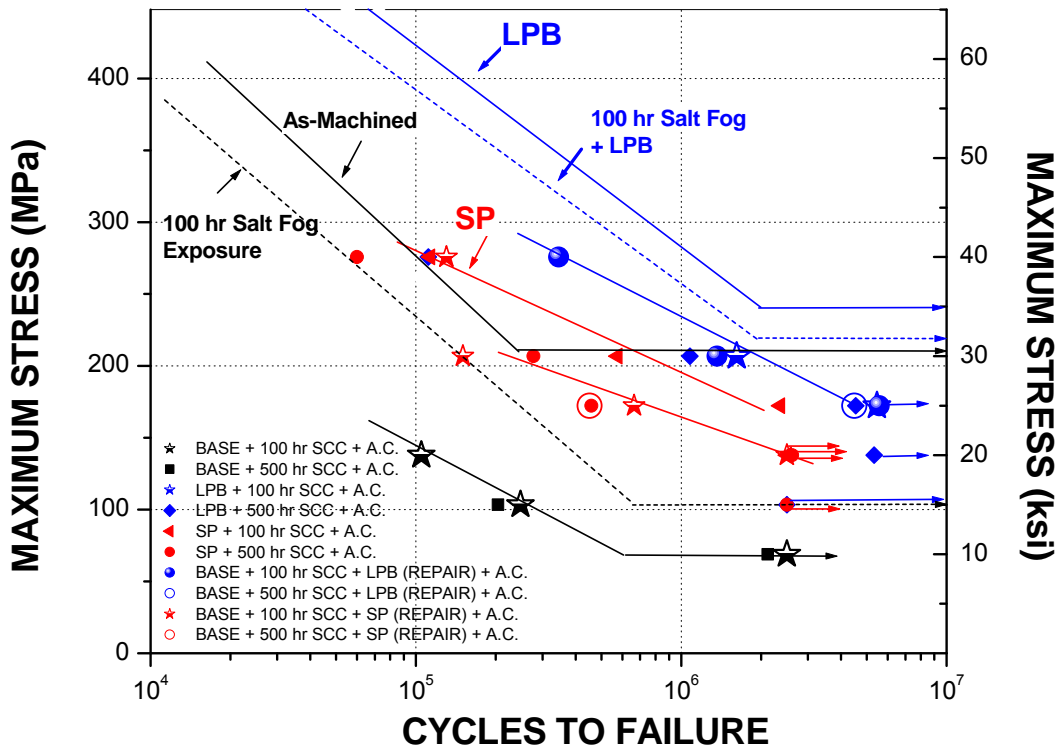
HIGH CYCLE FATIGUE DATA AA7075-T6, 4-point Bending, R=0.1, 30 Hz, RT

Figure 1: S-N curve for AA7075-T6. The LPB process increased the corrosion fatigue life by an order of magnitude or greater in all conditions. As a repair process LPB restored the fatigue life to greater than that of an undamaged and untreated specimen.

Figure 1 shows the S-N curves for the conditions tested. Figure 2 shows the fatigue strength at 10 million cycles. The LPB process improved fatigue strength by greater than 1.5X over the SP treatment under active corrosive conditions during testing. LPB used as a repair process on as-machined + SCC exposed specimens was able to restore the fatigue life to greater than that of SP + SCC specimens. The fatigue life was improved by greater than an order of magnitude over the SP repair specimens. LPB repair processing was performed directly over the pre-corroded material with no prior cleaning other than a rinse in distilled water. The LPB process increased the fatigue life at moderate stresses by a factor greater than 100X over the SP treatment.

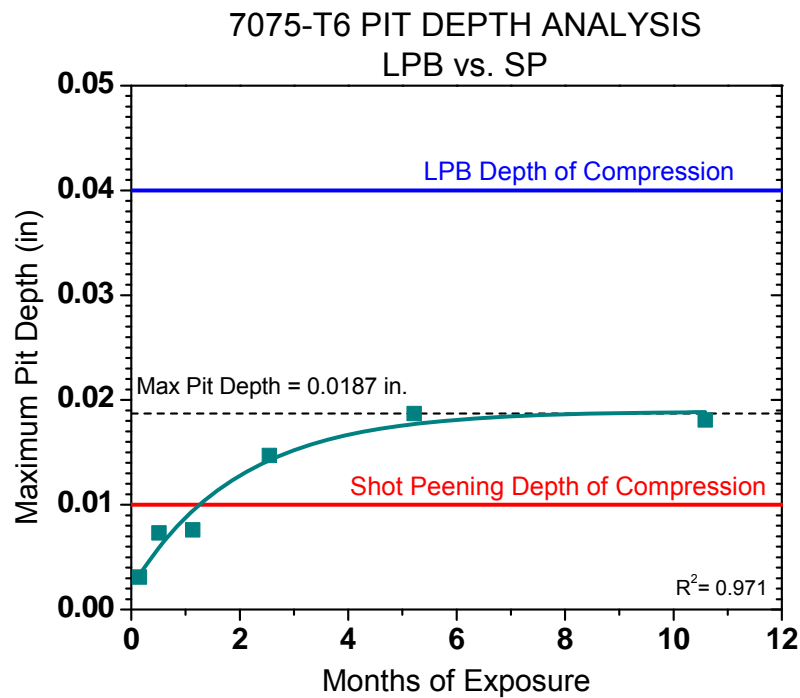
Figure 3: Max pit depth as a function of time. LPB had ~ 2X greater depth than the deepest pits. Pit depths exceeded SP depth of compression and reduced fatigue performance was evident as a result.

Figure 3 shows the maximum pit depth vs. exposure time found for either process compared to the depth of compression imparted. It was observed from the pit depth vs. time plot that the pit depth asymptotically approaches a maximum depth. The maximum pit depth was nominally 18.7×10^{-3} in. (0.475 mm). LPB produced a depth of compression over 2X greater than the max pit depth observed. By introducing compression deeper than the maximum pit depth the HCF damage tolerance was dramatically improved as shown above.

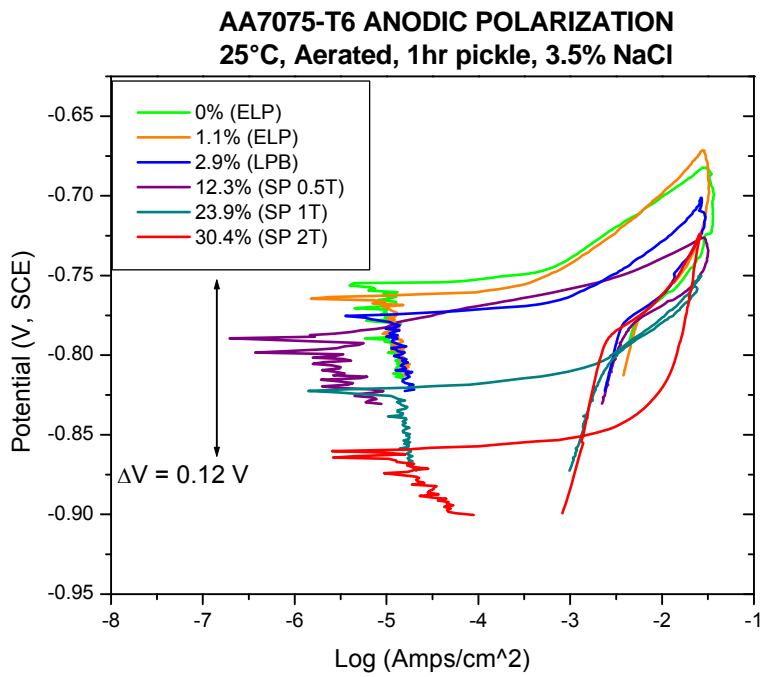
Figure 4: Anodic polarization testing of AA7075-T6. The surface treatment and resulting percent cold work is shown in the legend. As the percent cold working decreases the OCP becomes nobler, decreasing the corrosion rate.

The results of the anodic polarization tests performed revealed a shift in the OCP of the specimens that is dependent on the percent cold work. Specimens were tested with varying degrees of cold working to observe the change in OCP. The OCP (V, SCE) and current density (A/cm^2) both increased as a function of increasing cold work. This implies greater electrochemical activity at the surface of highly cold worked material and results in a greater propensity to corrode at a faster rate. Figures 4 and 5 show the anodic polarization curves and a linear fit of the OCP vs. cold work for AA7075-T6. The amount of cold working is indicated for each surface treatment.

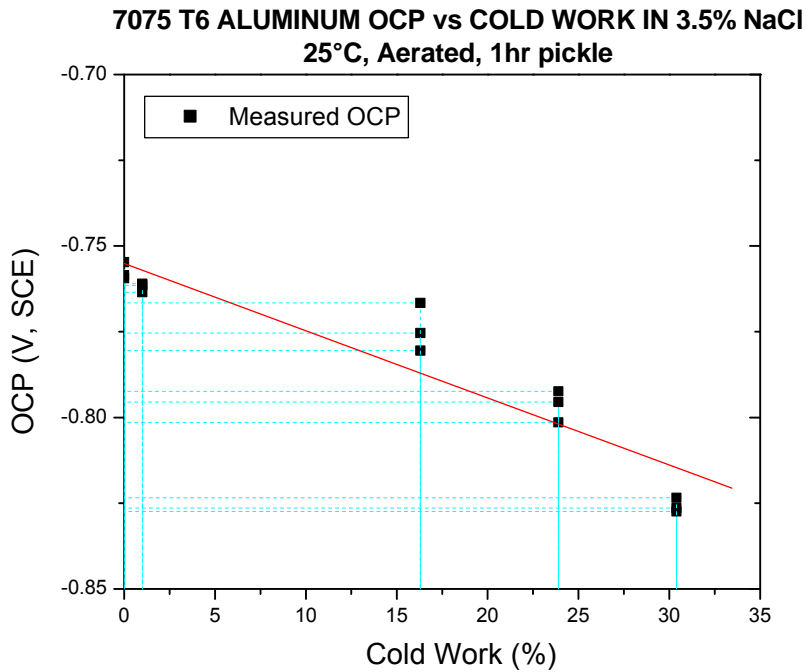
Figure 5: Linear fit of the OCP vs. percent cold work for AA7075-T6. Three repeat measurements were made at each cold work percentage tested.

The 200% (2T) SP process produced the highest percent cold work with nominally 30.4%. The electropolished specimens had 0% cold working after removal of 0.010 in. from the surface. The LPB process generated an average of nominally 2.4% cold working. The change in OCP between the 30.4% cold work and 0% cold work was nominally 0.12 V, SCE.

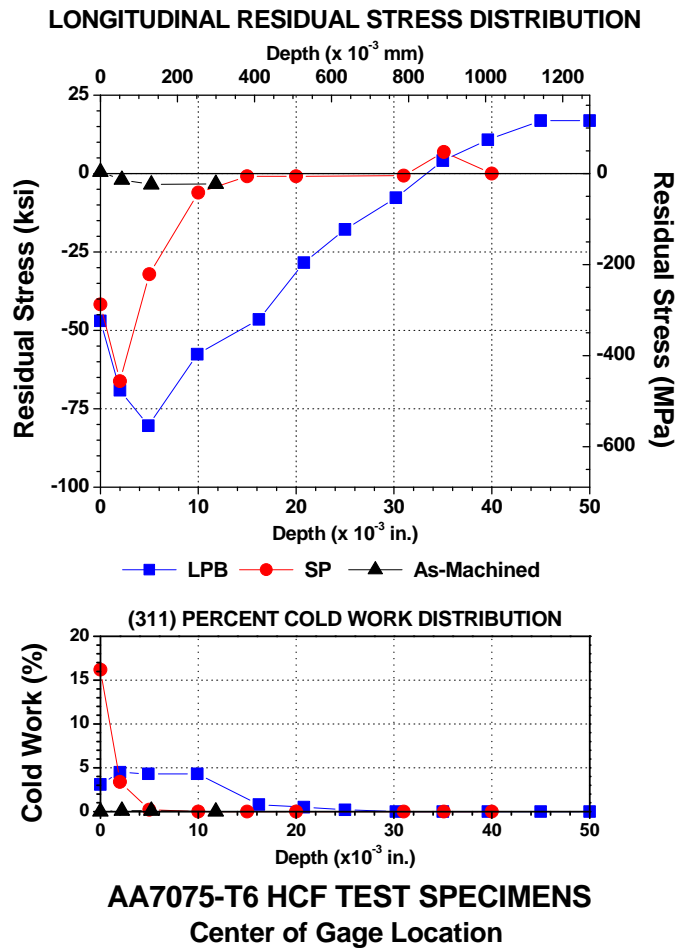
Figure 8: Residual stress distributions for each surface treatment on AA7075-T6. LPB processing provided greater magnitude and greater than 3X depth of compression than SP with less than 5% cold working.

X-ray diffraction results for AA7075-T6 HCF specimens are presented graphically in Figure 8. Compressive stresses are shown as negative values, and tensile stresses as positive, in units of ksi (10^3 psi) and MPa (10^6 N/m²). Compared to SP, LPB processing produced a compressive residual stress field with an 18% greater magnitude of compression and over 3X the depth of compression. The random impact of shot during the SP process created multiple impacts at the same location on the specimens. This repeated plastic deformation produced high cold working in SP treated specimens leading to the increased electrochemical activity as well as instability under thermo-mechanical stressing. The LPB process produced much less cold working than SP ensuring the deep compression remains stable, even at elevated temperature. The depth of compression from the LPB process greatly exceeds the average pit depth observed, preventing fatigue crack initiation from pits shallower than the compressive field. This result is reflected in the improved fatigue performance and more noble OCP values shown above.
