2017 Department of Defense – Allied Nations Technical Corrosion Conference

Student Research in Progress Symposium

DAMAGE EVOLUTION IN COATINGS AT LAP JOINTS

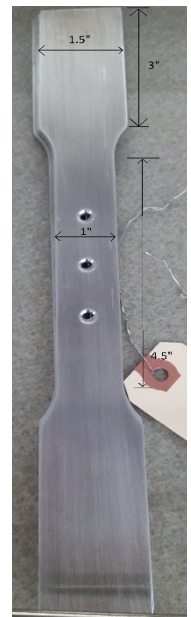
Figure 1
as received
sample

2024-T3 and 7075-T6 aluminum sheets were machined into dogbone samples similar to "Specimen 6" in ASTM E8/E8M -15a with holes and countersinks added for rivets, as shown in Figure 1 (a sample as received from the machine shop). Some samples were machined with an intentional defect in the countersink where the countersink was drilled 10 degrees off from the normal angle. The samples were polished with 600 grit SiC and degreased by cleaning with DI water, acetone, ethanol, and DI water (in that order). The rivets were tightened to a constant torque (the collars were designed to have a part break off at the desired torque), and the samples were cleaned again in the same manner as they were cleaned after polishing. Two inches on both ends of the samples (in the grip section of the dogbone) were taped off to prevent them from being coated. On the day of the coating application, the PreKote was applied first. Then the MIL-PRF-23377K epoxy primer was applied, followed by the MIL-PRF-85285E polyurethane topcoat. A spray gun was used to apply the coatings. After the coating dried, silicone was applied to the collars on the backside of the sample to prevent coating failure/ corrosion from initiating there.

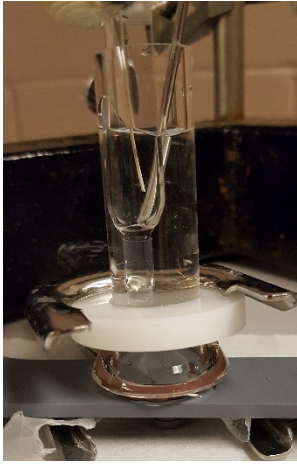
Figure 2
small paint test cell

Electrochemical Impedance Spectroscopy (EIS) tests were performed on each rivet individually. A small O-ring cell was used to isolate each rivet for a separate EIS scan, using a Silver/Silver Chloride (Ag/AgCl) reference electrode and a stainless-steel rod counter electrode, as shown in Figure 2. This paint test cell had a diameter of only 1.5 cm, allowing for EIS tests that isolated each rivet. The EIS scans were performed at the open circuit potential, and scanned from 100,000 Hz to 0.01Hz with an AC voltage of 10 mV ms, collecting 10 data points per decade. Then the sample was fatigued while exposed to a 5% NaCl solution. The fatigue cycle used had a peak stress of 11.7ksi, R ratio of 0.05, and a frequency of 5

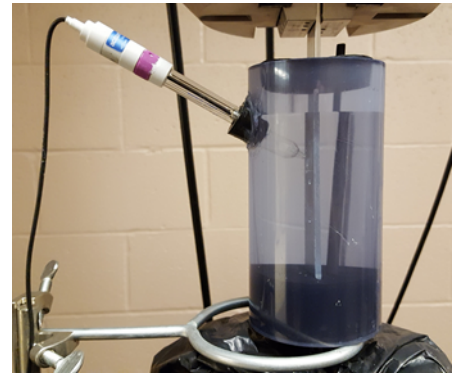
Figure 3
in situ EIS test cell

Hz for a total of 10,000 cycles. EIS was also recorded during the fatigue cycle, using a cell that fits over the entire gauge section of the dogbone sample, and contains the 5% NaCl solution, as shown in Figure 3. After collecting EIS data post fatigue testing, the

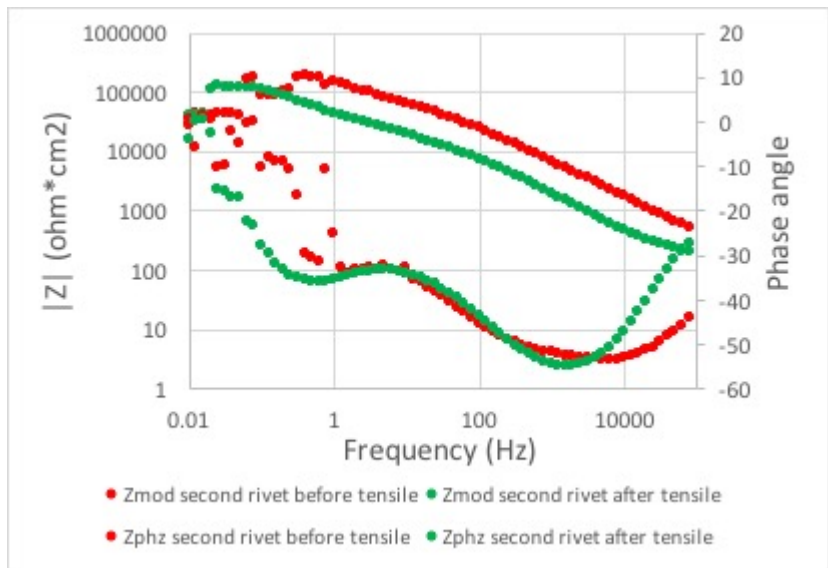
Figure 4. Bode plot of second rivet!

EIS results for a coated 7075-T3 sample can be seen in Figure 4. This figure shows the EIS results on the same rivet before and after the fatigue step. The phase data shows that there are two time constants in the initial data, which is likely due to pore resistance. The data shows a consistent reduction in the resistance (“Zmod”) after the sample was fatigued for all three rivets (only data from one shown here as the data from all three rivets looked very similar to each other).
